RE: Progress report for February 2009 activities - Hecla Mining Company Apex  
Site (EPA ID No. UT982589848, Docket No. RCRA-8-99-06)

**SUBJECT:** Progress Report No. 58 for period ending February 28, 2009; Pond 2 Final Closure - Apex Site, Washington County, Utah

TO: Paul Glader (Hecla Mining Company)  
FROM: Doug Gibbs (Monster Engineering Inc.)  
DATE: 2/9/09  
SUBJECT: **Surface Monument Survey Data Review – Apex Site**

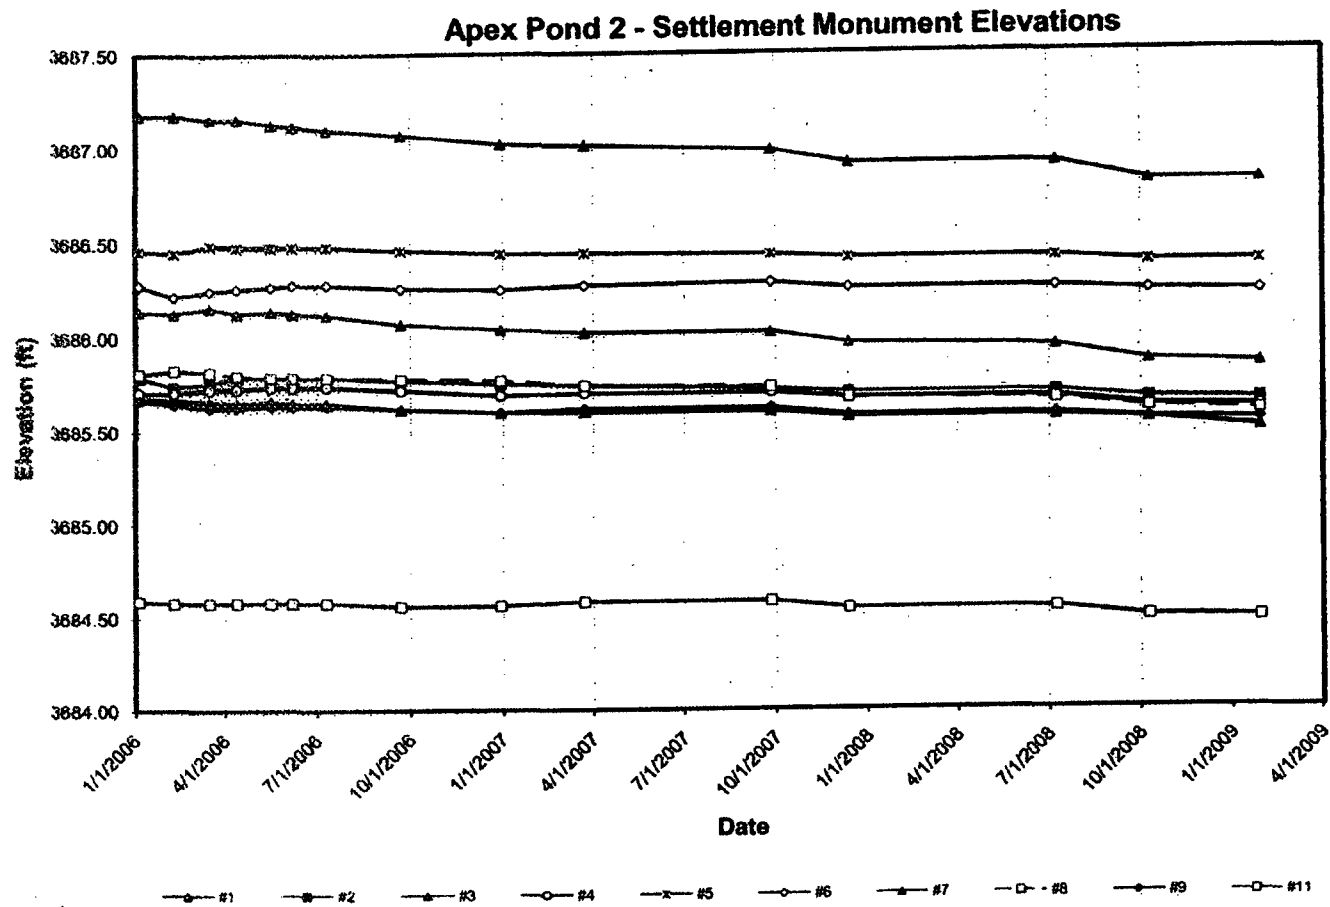
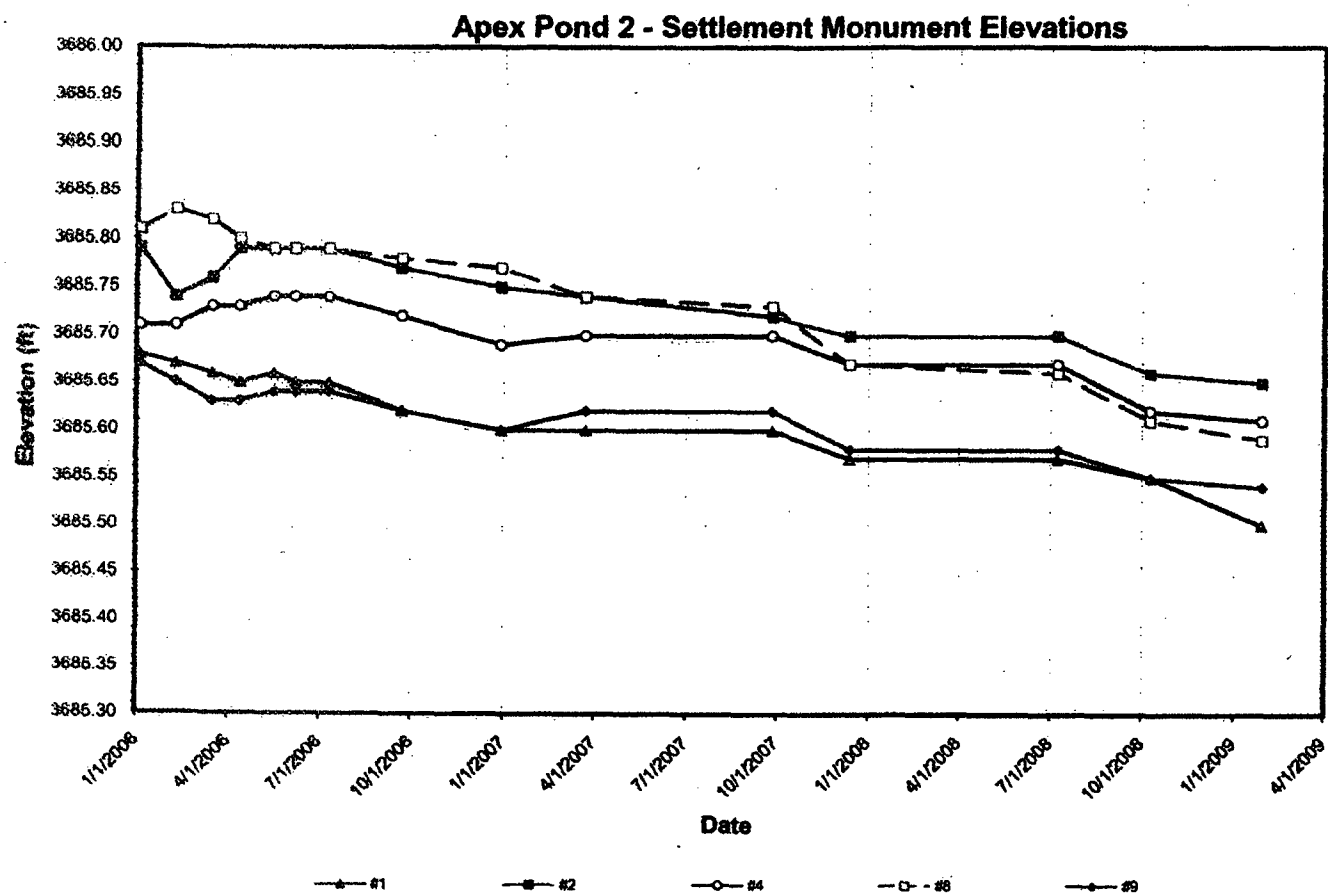
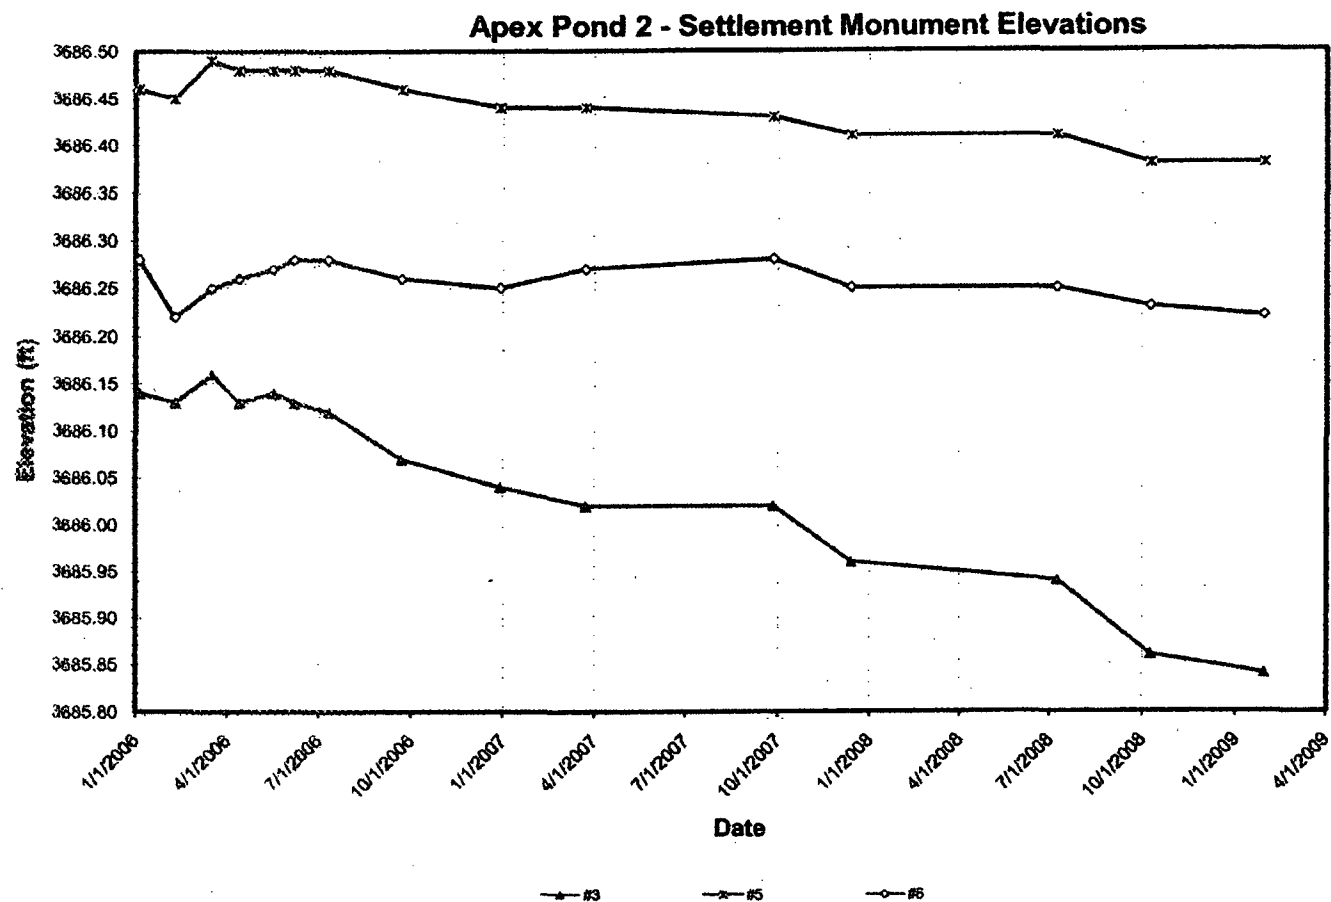
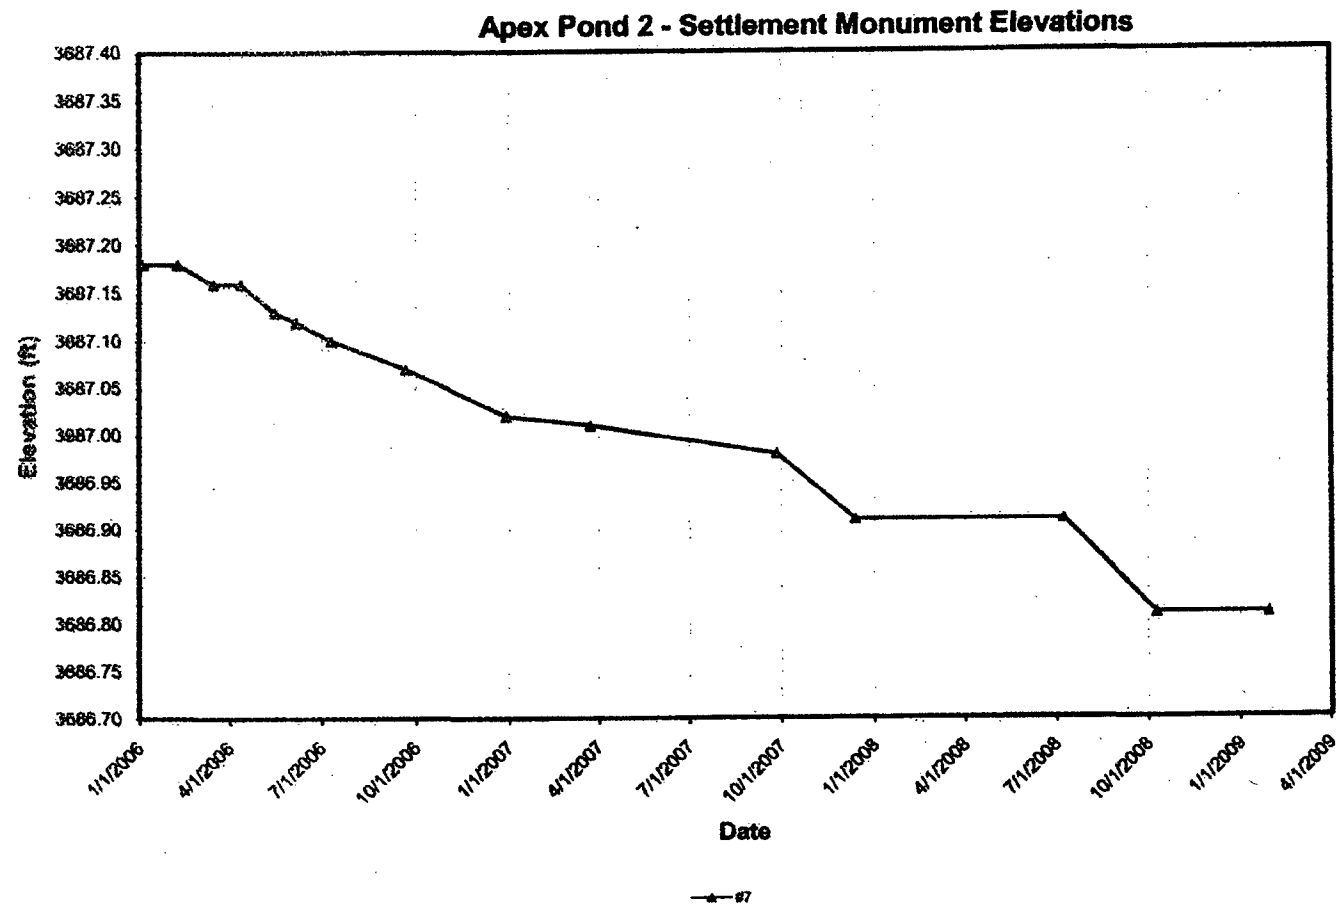
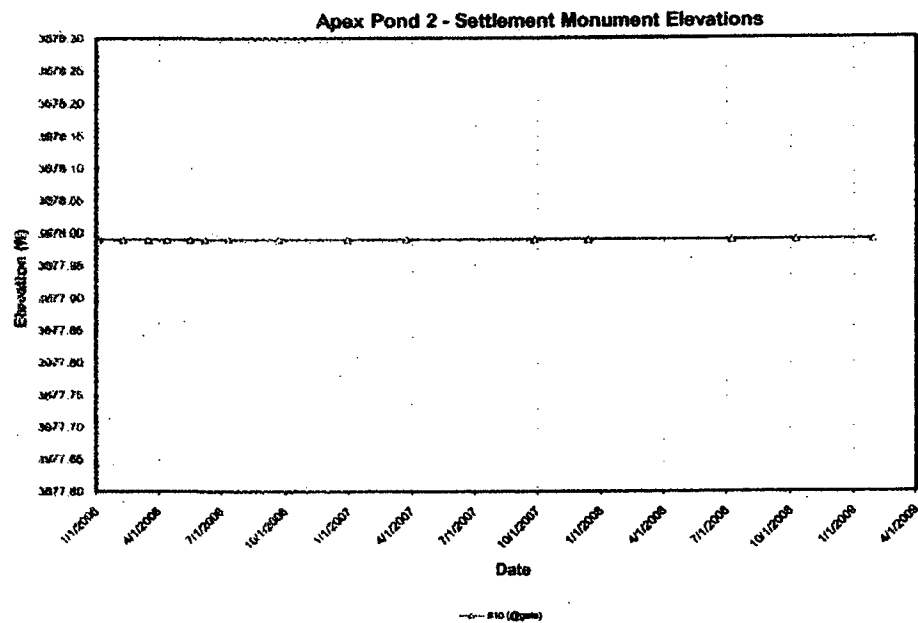
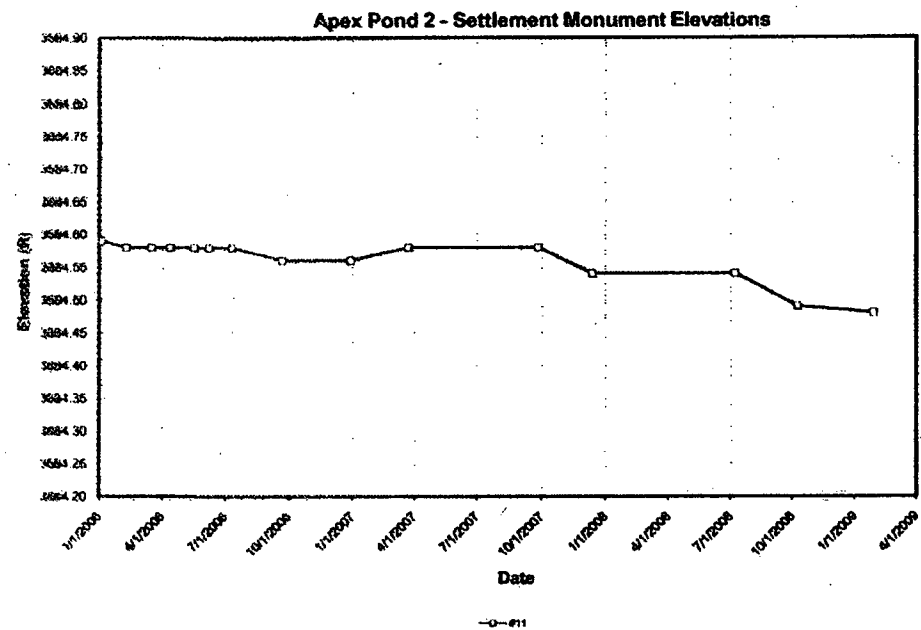
To date most apparent movement from period to period can be attributed to surveying accuracy limitations as data shows individual monument elevations both increasing and decreasing in elevation. However, when data for the monuments is "corrected" by adjusting the survey data to

maintain a zero elevation change at Monument #10, then a general trend of decreasing elevations becomes apparent. All elevation data provided by Alpha Engineering is presented graphically on the following pages. The first graph shows all monuments (except monitor #10 the baseline point) on a scale that allows all data to be compared. The next five graphs have expanded and equivalent "Y" axes scales in order to more clearly show elevation changes, and for ease of comparison between graphs.

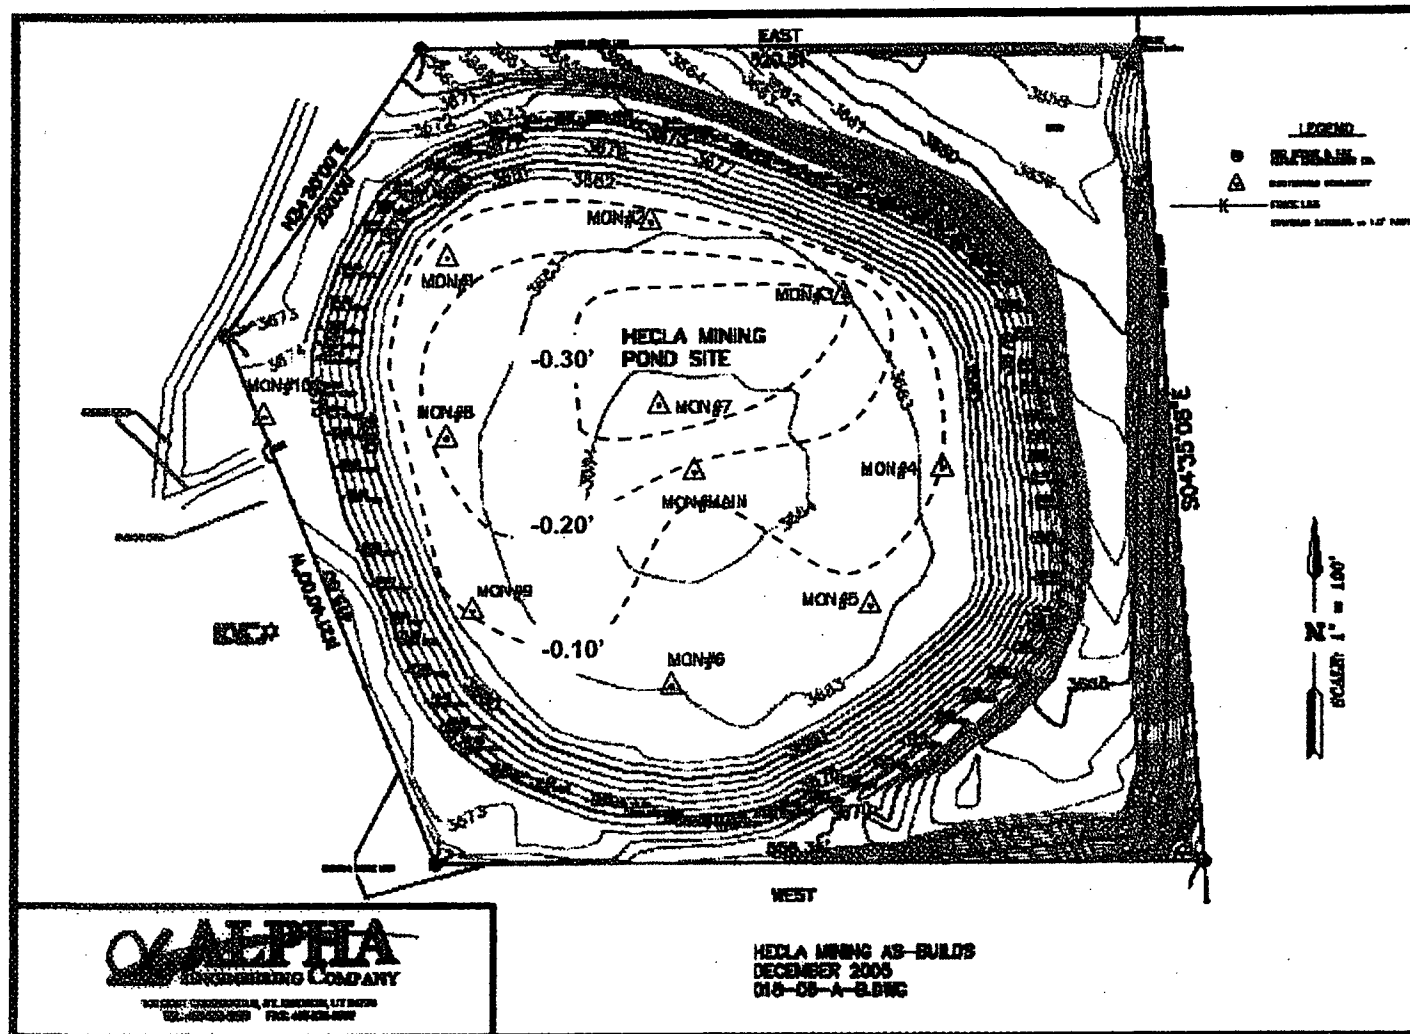
Survey data shows that the northern half of the impoundment has settled slightly more (between 0.14 and 0.3 feet) than the southern half (0.06 to 0.13 feet). A plan view of the impoundment showing each monument location (provided by Alpha Engineering) is attached on the last page of this document. Included on this map are contours showing approximate total settlement of the top surface since monument installation. The largest measured settlement is, as expected, near the center of the impoundment (monitor #7) at -0.37 feet. Slightly greater settlement in and nearer the center of the impoundment is to be expected as significant quantities of fill were placed in this area during construction. Additionally, greater settlement should be expected on the northern half of the impoundment based on the locations and methods utilized to place the original cover materials (prior to final reclamation activities). One portion of the initial reclamation project consisted of placing a temporary earthen/rock cover over the impoundment waste materials. According to Chris Gypton and Alan Wilson, these cover materials were initially dumped into the impoundment in the southwest corner and then were pushed across the impoundment towards the northeast corner. This placement method created a mud wave of unconsolidated waste which moved towards the northeast corner, and eventually a thicker deposit of unconsolidated waste materials in the northern half of the impoundment.
